# Study of Microscopic Analysis and Nonlinear Behavior of Damaged Steel Pipe Using Composite Materials

**Abstract** -This paper presents studies of microscopic analysis and nonlinear behavior of composite system for the rehabilitation of steel pipes by analytical models, based on the fracture mechanics and finite element techniques were developed to evaluate the deflection, failure pressure (blister pressure) and stress strain curves for damaged area [1,2].

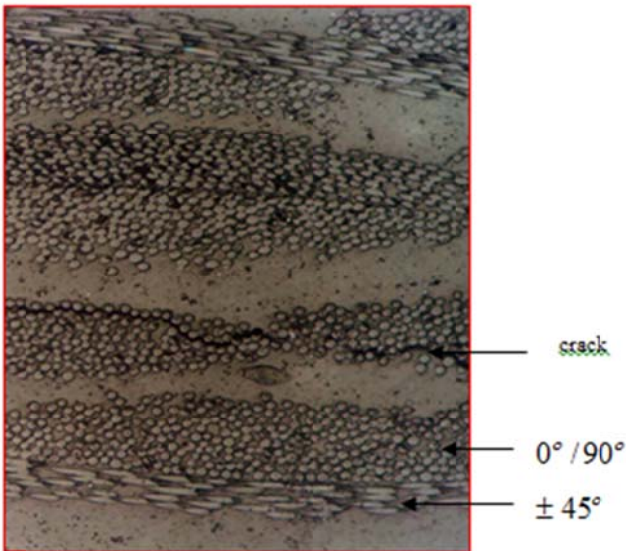
Figure 6 shows an optical micrograph of a polished sample. The tested pipe can be seen. The black lines are matrix cracks. It can be seen that the cracks appeared and traveled through the ply thickness to reach the nearest interfaces and propagated transversely in the resin matrix between fibers.

Fig.6. Shown photo-micrograph of polished sample from repaired laminate. Black lines are transverse cracks and white dots are fibers.

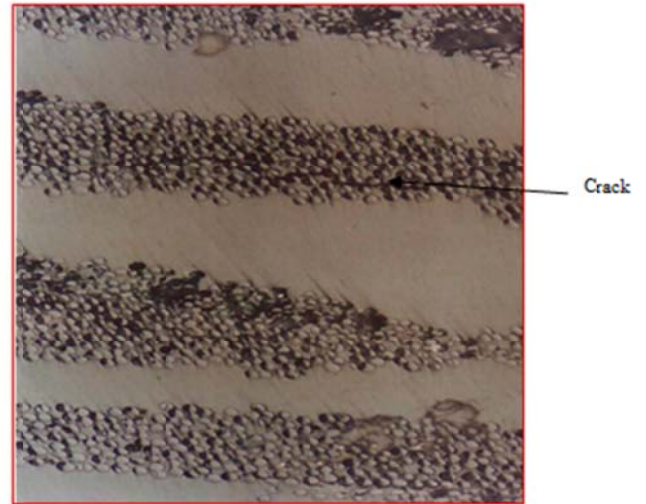
Other examples of transverse matrix cracks are illustrated in Fig 7 (a), (b) and (c). Fig 7 (a) shows micro-cracks propagated from the void in two opposite directions. Fig 7 (b) illustrates a micro-crack induced by a micro-void in the interface region between plies and Fig 7 (c) illustrates a micro-crack in the interface region between plies. One possible explanation for these cracks is that the voids, which were entrapped during the manufacturing process [1,2] caused a stress concentration in the repairing laminate at region defected hole.

Fig.7. Shows optical micrographs of polished sample (c) Two transverse micro-cracks propagated in a lamina.

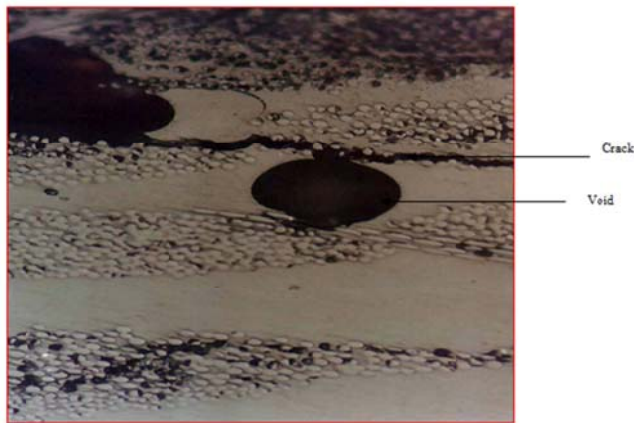
Figure 7. Shows optical micrographs of polished sample (a) transverse cracks propagated in opposite directions after being initiated in a void pocket in the lamina in a section at region defected hole.

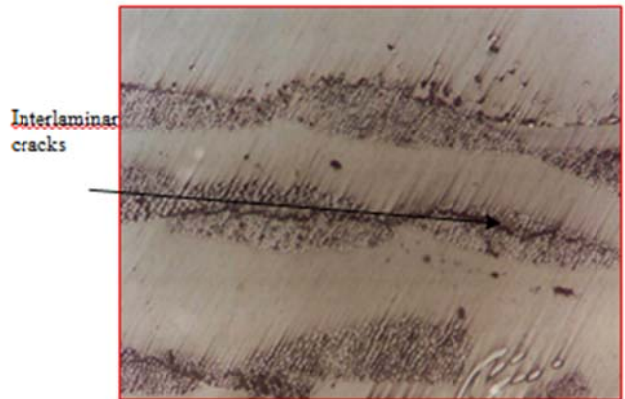
Figure 8 (a), (b) and (c) shows interlaminar micro-cracks propagated parallel to the lamina plane near the interface between plies and interlaminar cracks running in the interface region between the ply. This type of crack is probably formed in response to the interlaminar shear strains which may develop due to the high isotropic interaction between the plies. The occurrence of interlaminar cracking may cause continuous crack paths which increase the probability of weepage occurring by increasing the length of cracks crossed by other cracks [6,7] Figure 9. shows optical micrographs of polished samples. Fig 9 (a) shows a delamination failure which occurred between two plies. This delamination may occur as a result of interlaminar cracks. The delamination may lead to plies separation as illustrated in Fig 9 (b) and (c). Similar results have been presented by [8]. They concluded that in filament wound composite tubes

Fig. 8. Shows optical micrographs of polished sample. (a) Interlaminar cracks propagated parallel to the lamina plane in the interface between plies.

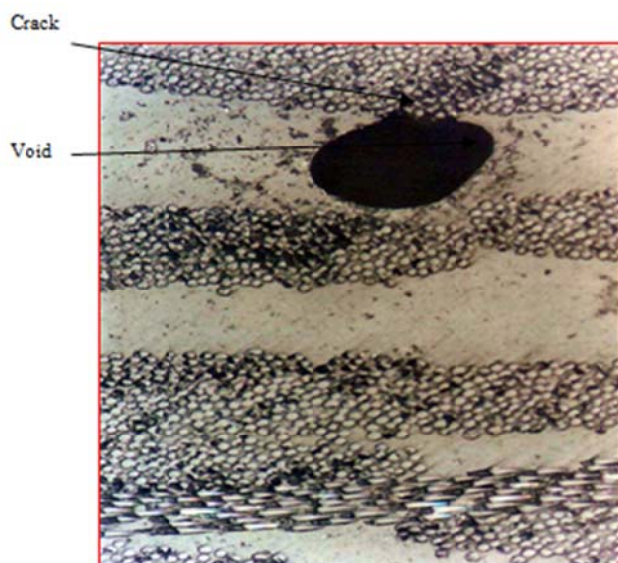
Fig.7. Shows optical micrographs of polished sample (b) transverse micro-crack initiated in a void pocket and small cracks propagated through the thickness.

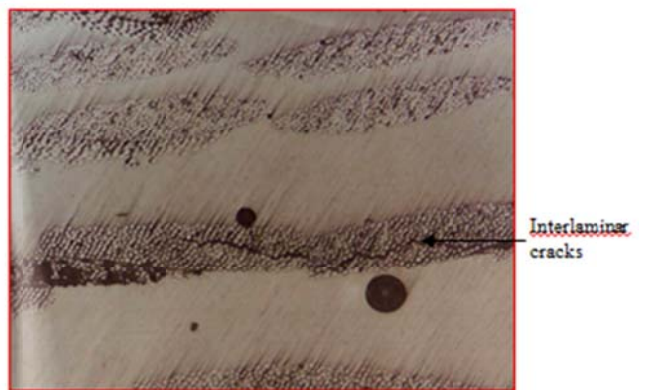
Fig. 8. Shows optical micrographs of polished sample. (b) Interlaminar cracks propagated parallel to the lamina plane in the interface between plies.

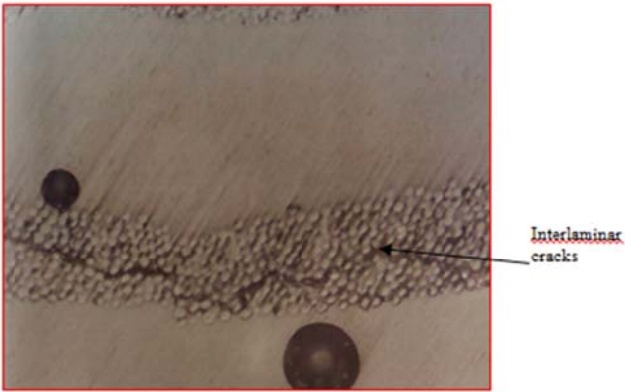
Fig. 8. Shows optical micrographs of polished sample. (c) Interlaminar cracks propagated parallel to the lamina plane in the interface between plies.

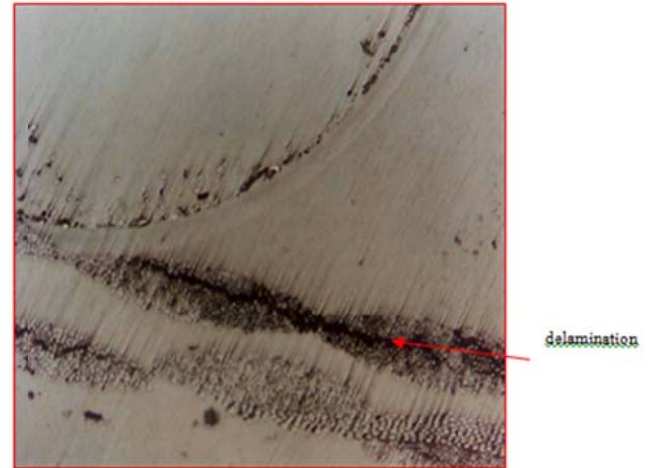
Fig.9. Shows optical micrographs of polished sample: (c) delamination leads to the separation of plies

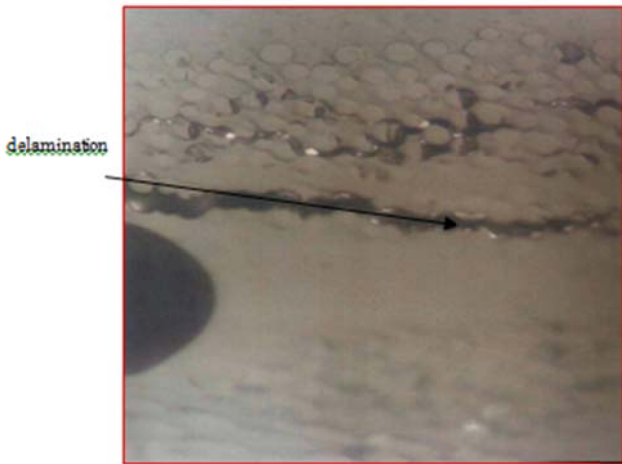
Fig. 9. Shows optical micrographs of polished sample : (a) delamination in the interface region.

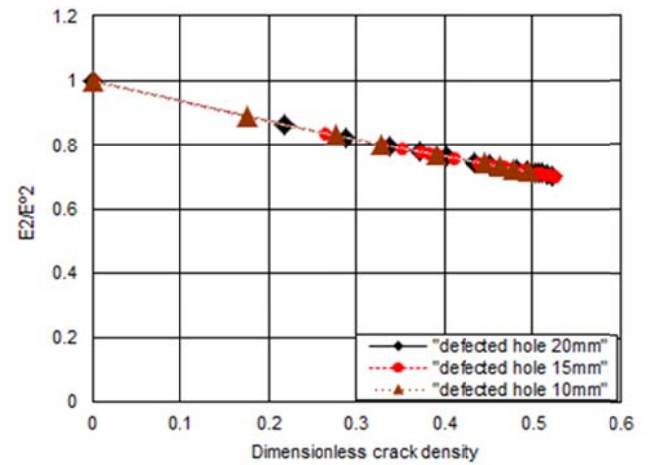
Figure 10 shows typical plot of normalized transverse modulus ( $E_2/E_2^o$ ) versus dimensionless crack density ( $\rho$ ) for defected holes of 20mm, 15mm, and of 10mm. It can be seen that curves decrease with increase in crack density. This decrease is related to the degradation of modulus due to matrix cracks. Also it can be noted that the degradation of modulus in defected holes are approximately equal. This is due to the small holes defect. The values of

Fig.10. Shows normalized transverse young's modulus versus dimensionless crack density for defected holes.

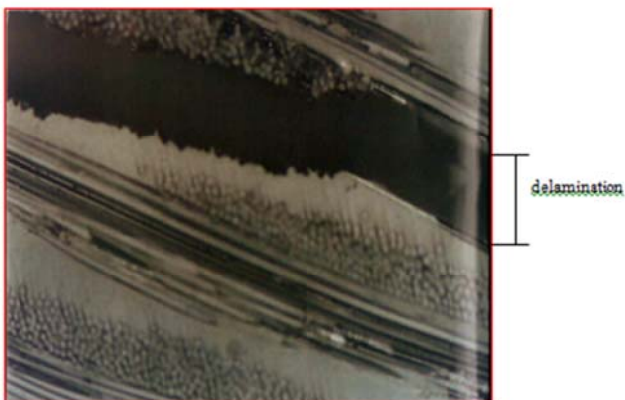
Fig.9. Shows optical micrographs of polished sample: (b) delamination leads to the separation of plies.
