# Nondestructive Testing of FRP Composite Structural Components and FRP Rehabilitated Bridge using Digital Tap Testing

Udaya B. Halabe<sup>1</sup>, Ruben M. Joshi<sup>1</sup>, and Hota V. S. GangaRao<sup>1</sup>

<sup>1</sup> Constructed Facilities Center, Department of Civil and Environmental Engineering  
West Virginia University  
Morgantown, WV, USA.

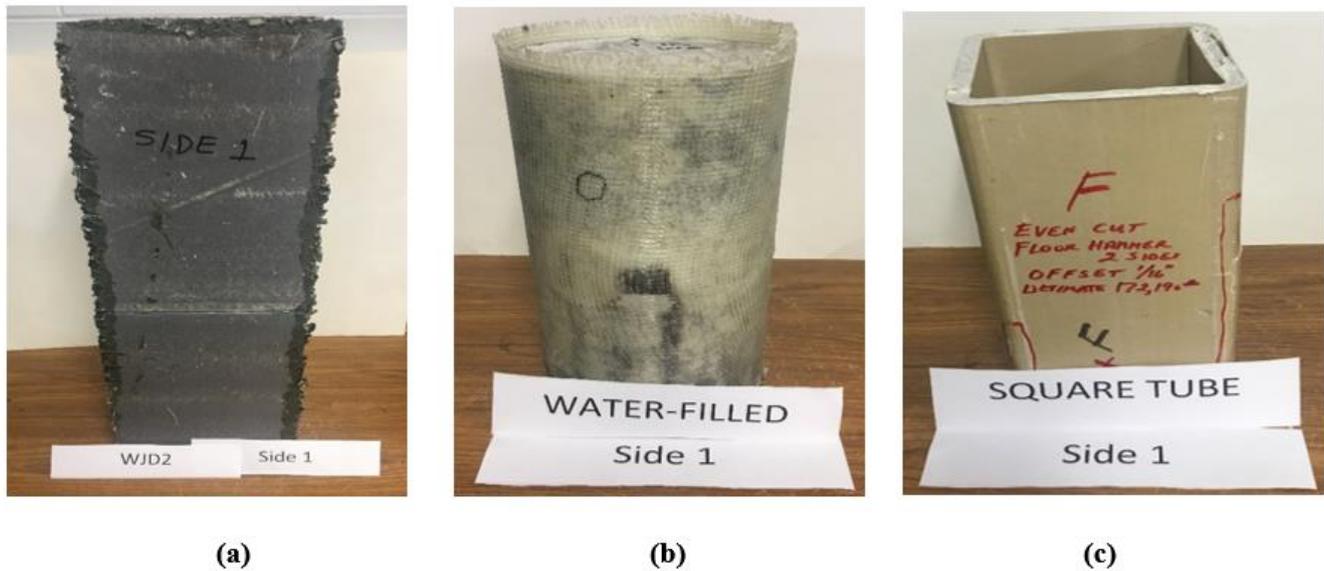
The specimen WJD2 had Side 1 with no wearing surface and the digital tap testing could be done on this side (Fig. 2(a)). The defect-free area had tap testing number in between 1090 – 1109 while over the embedded subsurface defect, it was around 1116 – 1135. These numbers do not suggest good results for digital tap testing on FRP bridge deck specimens which had flange thickness of 0.45" (11.4 mm) with defect depth of 0.3" (7.6 mm). Likewise, Side 2 of another bridge deck specimen WJD3 also gave similar results with numbers for good areas as 1101 – 1116 compared to 1098 – 1128 for defects. The deck specimen JD1, with no wearing surface on either side, was tapped using the digital tap hammer. Side 1 gave tap testing number in the range of 1097 – 1113

(microseconds) for good areas and in between 1120 – 1148 for the 3" x 3" sized defect. The tap testing numbers for the defect was not significantly higher than the good areas, therefore digital tap testing did not produce satisfactory results for the bridge deck specimen. For bridge deck specimen AS3, the uncovered Side 2 had a 3" x 3" sized debond which gave tap testing numbers as 1109 – 1130. The tap testing number for good areas on Side 2 of AS3 was in the range of 1083 – 1114, which shows the numbers for debonds are not 10% greater than good areas. Thus, AS3 is another specimen that provides unsatisfactory results for digital tap testing.

Digital Tap Testing, on the other hand, proved very effective when the GFRP wrapped concrete cylinders were tested. The air-filled and water-filled debonds gave numbers significantly higher than the surrounding good areas. Since the wraps were quite thin (1 layer and 3 layers, with thickness of less than 1 mm per layer or 3 mm total), the digital tap testing gave satisfactory results for these specimens. The defect-free areas on GFRP wrapped cylinder had tap test numbers in the range of 1075 – 1151 while the area above air-filled subsurface defect gave tap test readings in the range of 1801 – 2104. These numbers show that the defects underneath the thin FRP wraps can be easily detected using digital tap hammer. Similarly, the water-filled subsurface defects resulted in tap test numbers in the range of 1380 – 1475, which when compared to 1108 – 1130 reading for defect-free areas, could clearly be distinguished as defects (Fig. 2(b)). The composite square tube specimen gave numbers in between 2848 – 3178 for the delaminated area while the good area had numbers in the range of 1108 – 1128 (Fig. 2(c)). Table 1 summarizes the results of digital tap testing on bridge deck specimens, FRP wrapped cylinders and the square tube specimen.

Fig. 2. Laboratory specimens – (a) GFRP bridge deck (side without wearing surface), (b) GFRP composite wrapped concrete cylinder, and (c) GFRP square tube section

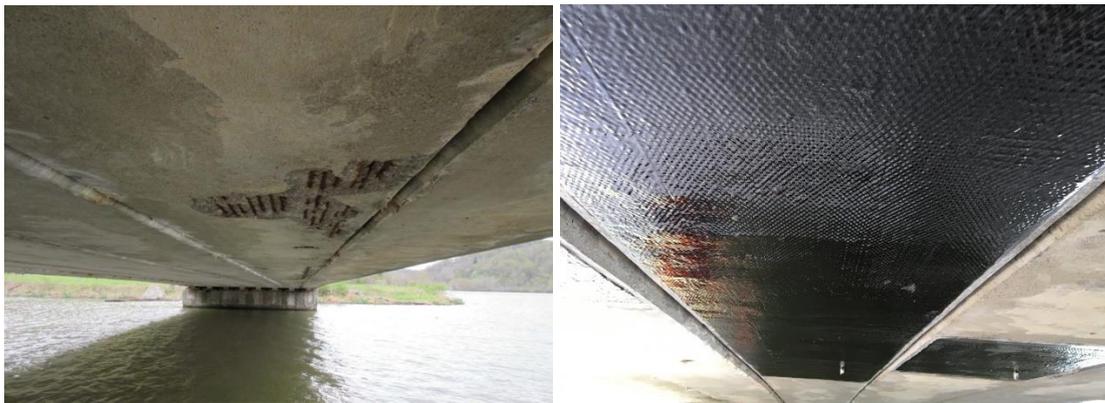
Fig. 4. Underside of the Whiteday Creek Bridge – (a) with exposed prestressing strands [4], and (b) repaired with CFRP laminates

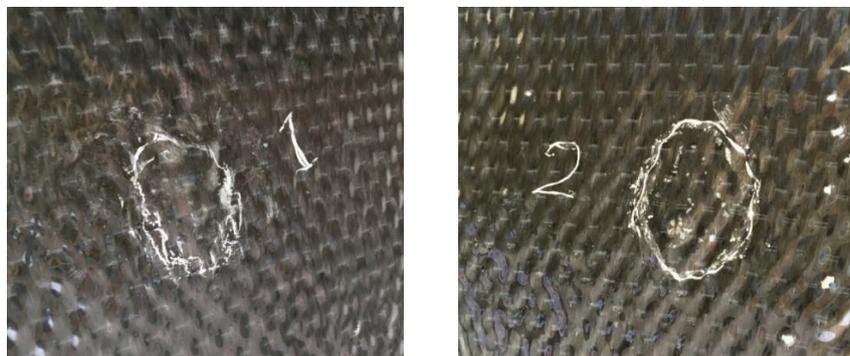
Fig. 5. Marked and labelled debonded areas in the CFRP bonded concrete box beams of Whiteday Creek Bridge

The Digital Tap Testing was conducted throughout the length of the CFRP bonded areas of the box beams. The tap testing results helped in detecting debonds between the CFRP laminate and the underlying concrete with debond sizes ranging from 1.5" x 0.75" to 4" x 3". Spots of size less than 1.5" x 0.75" (~ 1.1 inch<sup>2</sup>) were also located but these do not require any special attention. According to ACI 440.2R-17 [5], debonds of size less than 2 inch<sup>2</sup> are permissible as long as the area with debond is less than 5% of the total bonded area. In our field test, however, even the detected debonds of size as small as 1.5" x 0.75" (~ 1.1 inch<sup>2</sup>) was repaired using resin injection and the large ones (size ~ 4" x 3") were repaired by cutting off the CFRP fabric and replacing them with new fabric. Table 2 lists of all the debonds

The debonds identified from the nondestructive testing were marked so that the repair work could be conducted immediately by the contractor. Small sized debonds were repaired by injecting resin into them while large debonds, especially bulges, were repaired by cutting off the CFRP fabric and replacing them with new fabric. After the repair works, a quick assessment of the CFRP bonded beams was needed to ensure that no more debonds were present. Thus, digital tap testing was done again on October 2, 2017 to evaluate all the previously detected and repaired debonds.

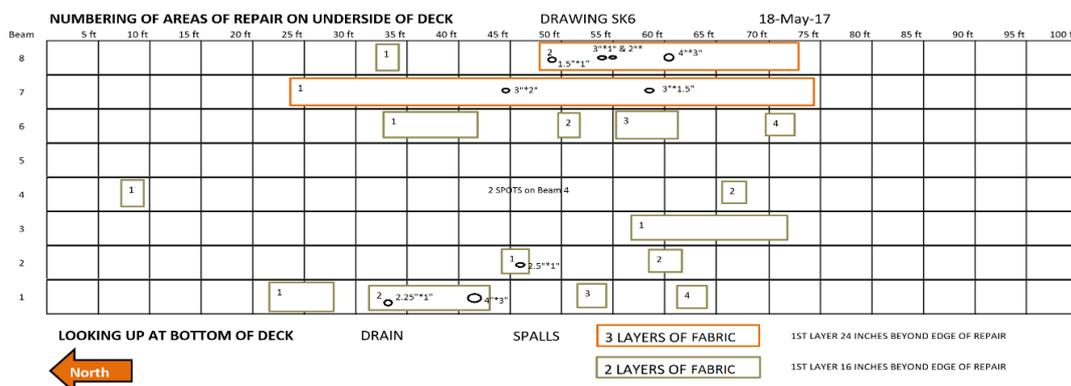
Fig. 6. Plan of the Whiteday Creek Bridge with numbering of beams and positioning of CFRP fabric laminates with debonds

detected by digital tap testing along with their sizes and the corresponding tap testing readings. Fig. 6 shows the plan of the main span with location of the debonds between CFRP fabric laminate and the underlying concrete.

Beams 1 through 6 were found to be free of debonds. However, Beams 7 and 8 had couple of debonded spots left.

Table 3 shows the list of debonds detected using digital tap testing during this second round of field testing. The previously identified debonds on Beam 7 – namely 7-1 and 7-2 – were still detected but the sizes of these debonds had decreased. The size of spot 7-1 had reduced from 3" x 1.5" to 2" x 1" and that of spot 7-2 reduced from 3" x 2" to 2" x 1". Debond 7-1, however, did not show a high number in tap testing reading but a hollow sound could be heard from the concrete upon tapping. This indicated that there was no debond between CFRP fabric and underlying concrete; instead, there was a delamination within the concrete itself as indicated by the hollow sound. For Beam 8, debond 8-2 of size 4" x 3" was still present, which was the bulge in the CFRP fabric. At the edge of the CFRP fabric on central area of Beam 8, tap testing gave readings that indicated there was debond in that area. This was called Spot 8-5, which could have formed during the repair work. All the debonds were marked and the contractor was asked to repair these by either injecting resin or cutting and replacing the debonded CFRP laminate.
