Zinc-Plated Roofing Sheets and the Effect of Atmospheric Pollution on the Durability of the Sheets.

Aondona-Paul IHOM and Aniekan Offiong

University of Uyo, Department of Mechanical Engineering, PMB 1017 Uyo, Akwa-Ibom State –Nigeria.

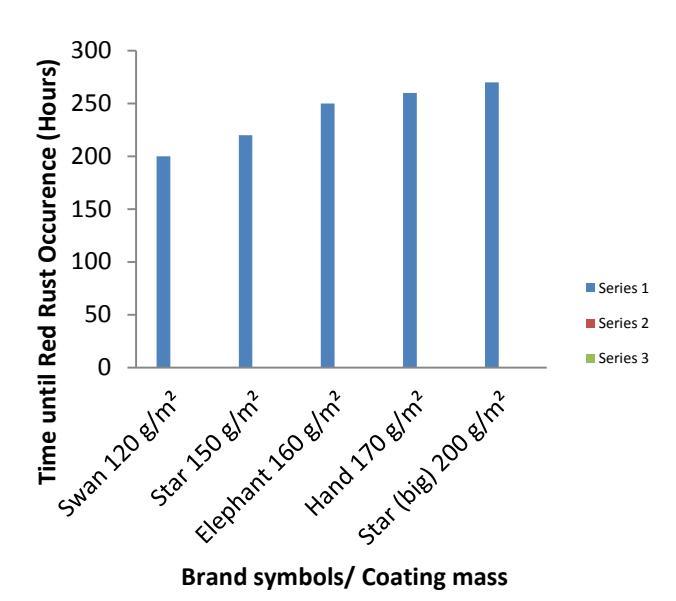
Figure 1 shows brand symbols and time until red rust occurrence. The figure showed the time taken for red rust to appear on different brand symbols with different coating mass. The figure shows that as coating mass increases the time until red rust occurrence also increases. With a coating mass of 120g/m² the time until red rust occurrence came up to 200hours. The number of hours increased to 270 hours corresponding to a coating mass of 200g/m^2 . These observations agree with other works in refs (NSC, 2007, JIS, 2007). It therefore means that for corrosive environments, galvanized steel sheets with high coating mass should be preferred to offer better corrosion resistance.

- 4. For corrosion-prone area the study advised that galvanized steel sheets with thick coating mass should be used.
- The study also observed that the aim of roofing with galvanized steel sheet is not only for protection from rain and wind but also for aesthetics. The red rust on galvanized steel sheets therefore disfigures the building. Hence the effect of the corrosion as a result of pollution therefore goes beyond durability of the roofing sheets.

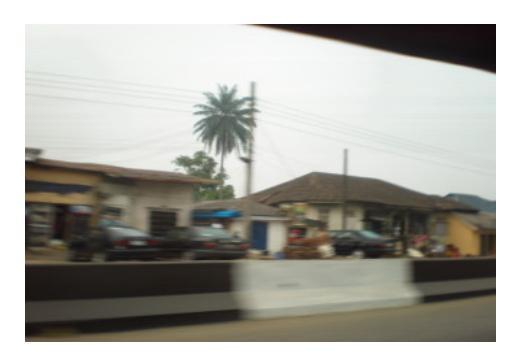
Plate 1: Buildings Close to the Main Road and Roofed in the Year 2001 had Shiny Roofs but have now (2013) turned Completely Reddish Brown

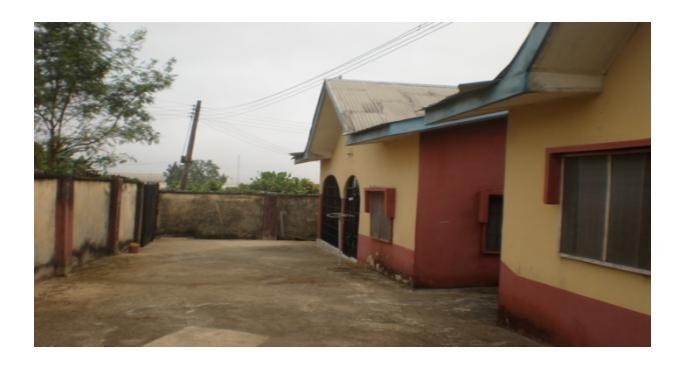
Plate 2: Building roofed in 2003 showing Light- Brown Rust Spot uniformly on the Zincplated roofing Sheets

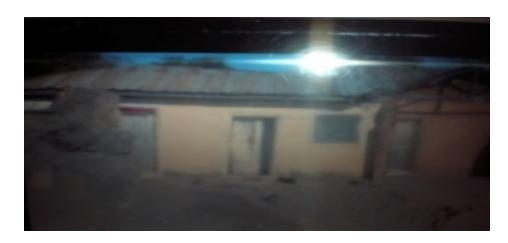
Plate 3: Building roofed in the Year 2004 showing Reddish- Brown Rust Spots

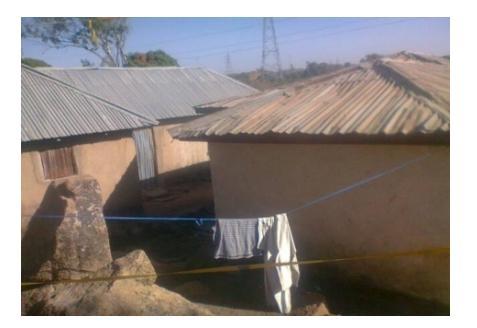
Plate 4: Two Buildings the First from the left was Roofed in Year 2007 and the Second Was Roofed in 2004. Rust has taken Away the Shining Beauty of the Second Roof

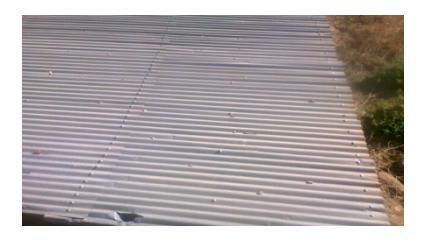
Plate 5: Building Was Roofed in Year 2010; Dulling of the Surface has Already Taken Place

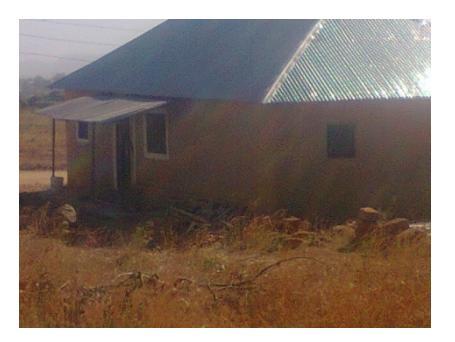
Plate 6: Building was Roofed in the Year 2013, still Shining in some Areas but getting Dull in Others.
