Analysis Of Atm Premise Security Aspects On Preventing Cardholder's Pin Theft And Attack A Case Of Crdb Branches In Dar Es Salaam, Tanzania

Abstract—Security in automatic teller machine (ATM) is one of the challenging subjects in security matters nowadays and particularly in Tanzania. Escalation of ATM thefts is overwhelming commercial banks in the country which are increasingly finding it difficult to cope with huge requests to compensate hundreds of victims of the electronic fraud. Tanzanian Banks are losing hundreds of millions of shillings in ATM card skimming and their customers are worried on the fate of their deposits. Securing PIN and preventing cardholders from attack at ATM site have gained a considerable attention during these recent years of advancement of science and technology. People have become victims of identity theft and assaults as a result of inadequate security measures at ATM premise. The aim of this study was to analyze the ATM premise security so as to identify security weaknesses and provide pertinent remedies. The study extremely involved CRDB bank in Dar es salaam City which has many ATMs installed in different locations like supermarket, fuel station/

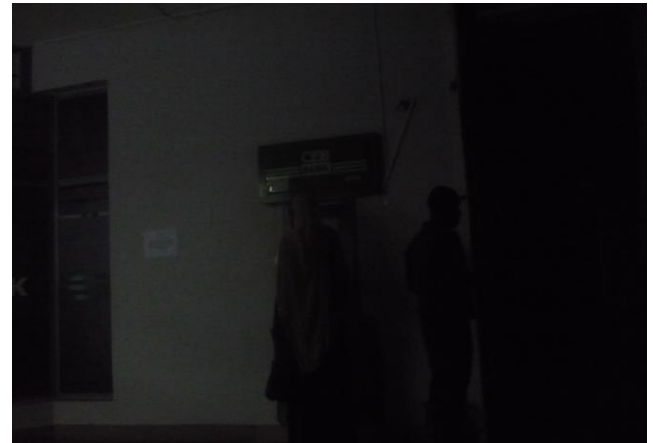
From the table above, 1 ATM site out of 15 was found to be very unsatisfactory due to the fact that it was not visible from public point of view and it was installed in an area which was not well-lit. 2 ATM sites were unsatisfactory, 3 ATM sites were somehow unsatisfactory as far as visibility and well-lit aspects are concerned especially during the night. The picture below is an evidence of the situation;

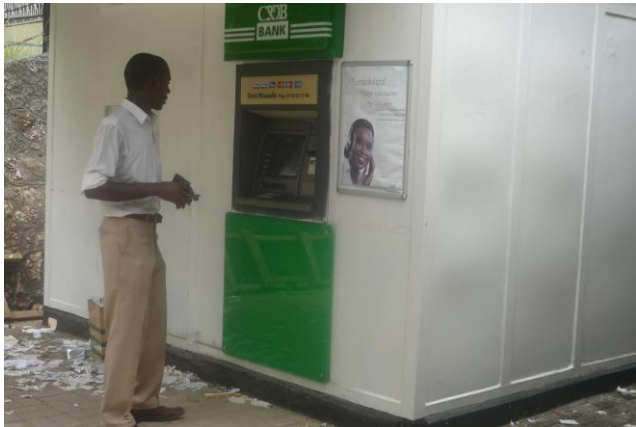
From the table above, 9 (30%) ATM sites were very unsatisfactory, 4 (13.3%) were somehow unsatisfactory, 14 (46.7%) were unsatisfactory. This has been attributed to by the fact that most of the ATM are on open area where there is not obscured fence which can protect the customer in service from shoulder surfing and spoofing as evidenced by the below picture

Absence of glass fence that prevents PIN against spoofing at ATM premise

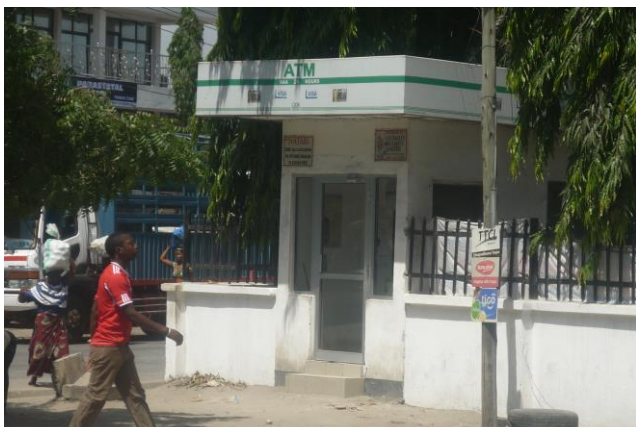
4 ATM sites (13.3%) had no places around where criminals could hide themselves. 8 ATM sites (26.7%) had places where there was low possibility for criminals to hide themselves and 18 ATM sites (60%) had places where there was high possibility for criminals to hide themselves .The picture below shows how the ATM premise is in intact with other surroundings which are good hiding places for offenders especially during the night.

As far as the security of ATM premise is concerned, the banks should proactively make a thorough identification of all possible hiding localities and try to remove them if possible before the installation of ATM. This will reduce the possibility of cardholders' physical attack, injury by robbers and bank.

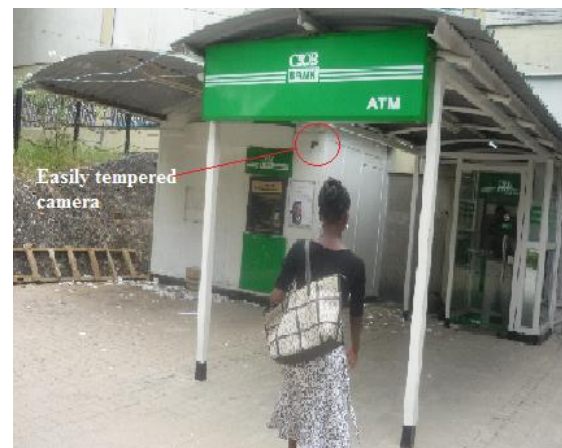
73.3% were having only one camera, which is unhealthy in security perspective due to the fact that it could be easily tempered or subjected to a single point of failure problem as evidenced by the picture below;

The CRDB bank in Dar es salaam should add more surveillance cameras and CCTV to the ATM premise in order to get rid of single point of failure problem which has been implicitly noted as evidenced by majority of ATMs having only one camera or CCTV. It should also incorporate foreign device detection system in the ATM premise to ensure that any malicious devices placed in ATM premises are detected as soon as possible.
