# Evaluation of the Runway at the Eduardo Gomes International Airport in Manaus

**Abstract**—Air transport is one of the most dynamic sectors of the world economy, as growing commercial demand stimulates the aeronautical industry to produce larger aircraft with greater capacity for transporting both passengers and cargo, resulting in faster and safer transportation. This development has had a direct impact on the tire-pavement interaction on airport runways, since landing and take-off operations are the most critical flight procedures in terms of safety. To this end, the maintenance of these structures is of the utmost importance in order to avoid accidents. One of the means of monitoring and conserving these pavements is through the measurement of friction and macrotexture. The information presented here was gathered from the runway at the Eduardo Gomes International Airport in Manaus, Amazonas, Brazil. The data indicated that, in spite of the high demand that leads to more intense air traffic, friction indices and macrotexture remained at a level considered safe. This result was due to regular maintenance procedures, such as rubber removal and layer rehabilitation.

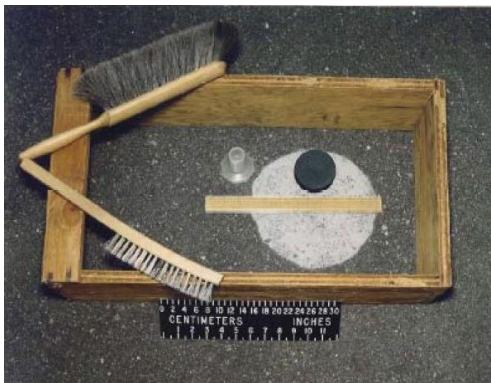
Fig5 - Materials for the Sand Patch test

For the macrotexture test the following materials were used: sand, with particle size contained between the #50 and #100 sieves, i.e. passing the 50 mesh sieve and retained on the 100 mesh sieve; metal ruler for measuring the sand patch diameter; protective device against wind effects; and a stamp, to contain the volume of sand (24 cm<sup>3</sup>) and spread this material on the pavement (Figure 5). Obtaining the runway's friction data involved the use of: the *GripTester* friction measurement device; a van, used to tow the meter trailer; a computer for data collection. The computer hardware contains the *Airbase* program responsible for processing all information obtained by the *GripTester* (Figure 6).

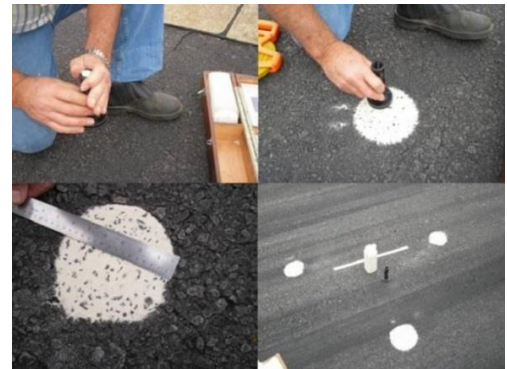
Fig 7 - Sequence of the Sand Patch test

In order to perform the macrotexture test, the metal cylinder was completely filled with sand. Subsequently, the contents of the cylinder were poured at chosen points on the pavement and spread uniformly, forming a familiar geometric figure, generally a circle. The parameters of the spreading area were measured in four directions (Figure 8). Average macrotexture depth on a runway should be not less than 0,60 mm (RA N<sup>o</sup> 236/2012 ANAC).
