# Experimental Evaluation of FRP Strengthened Concrete Bridge Girders for Flexure

**Abstract**—External Fiber Reinforced Polymer (FRP) fabric strengthening is an increasingly popular technique for strengthening and confinement of damaged concrete bridge girders. There is a general lack of knowledge on the full-scale performance of FRP strengthened girders. In this study, three full-scale girders were experimentally evaluated for flexural load capacity, failure mode, cracking and ductility. A unidirectional carbon FRP with one and two layers application, and U-wrap anchoring, was employed. Flexural FRP was found to increase the first cracking load by 7-14%, the ultimate load by 6-7% and the ductility by up to 25%. FRP U-wrap anchoring was instrumental in delaying cracking, increasing the ultimate load, delay FRP debonding and increase ductility. FRP debonding at the epoxy layer was the controlling failure mode, as opposed to the FRP rupture or debonding in the concrete substrate. Tested girders failed to reach the high predicted FRP debonding and rupture strains, possibly due to inadequate surface preparation using industry accepted practice.

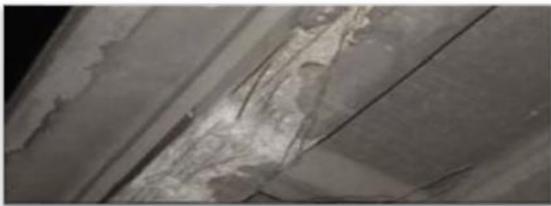
Fig. 1. Damaged and FRP strengthened pre-stressed concrete bridge girders.

(a) Damaged.

(b) FRP strengthened.

Over height vehicles collision due to low clearance of older bridges or increase of roadway overlay thickness is the primary cause of the first type of damage (Miller [4]). The damage may be minor, or could be severe that includes spalling of concrete and damage or breakage of prestressing strands, as seen in Fig. 1a. Therefore, for severe cases, the damaged girders are repaired and strengthened as soon as possible to maintain the safety and load carrying capacity of the girders. Among other repair methods, TxDOT has been using external strengthening of damaged concrete bridge girders with fiber reinforced polymer (FRP) fabrics since 1999. More than 30 such bridge strengthening has been performed in the state to date. The FRP strengthening is typically applied after any damaged prestressing strands are spliced and re-tensioned, and the spalled concrete replaced with new repair concrete (Fig. 1b). Besides providing additional strength, the FRP strengthening adds confinement to the concrete, prevent significant spalling of concrete in case of future damage at the same location, and increase the durability.

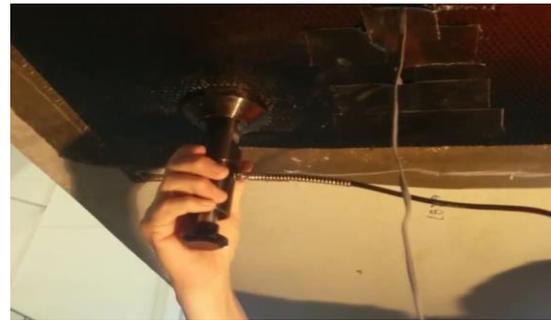
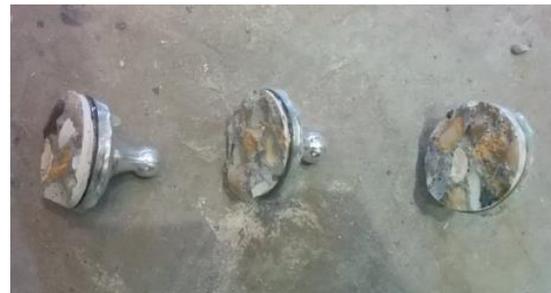
Fig. 9. Pull-off testing.

(a) Pull off testing.

(b) Failed samples showing good bond.

The strengthening of concrete structures by using FRP system depends mainly on the interface bond between the FRP sheets and concrete surface. The bond quality is affected by any lack of proper surface preparation, epoxy mixing, epoxy application and the FRP application onto the concrete surface. Inadequate bonding results in inadequate stress transfer and resulting insufficient composite action. One popular method to spot check the bond quality is the ASTM Pull-Off Testing (ASTM D7522 [18]). In this test, a 50 mm circular dolly is glued to the CFRP surface. After 24 hours of curing, the dolly is pulled off from the surface with a tension tester (Fig. 9a). If the failure surface is within the concrete substrate, a good bond quality is indicated. A failure in the CFRP or epoxy indicates inadequate bond quality. In the current study, three random pull off tests were performed on the girders with FRP. Only one sample showed adequate ASTM acceptability with failure in the concrete substrate, indicating good workmanship and bond quality (Fig. 9b). The other two samples had mixed failure modes involving partial concrete, FRP and epoxy failures.

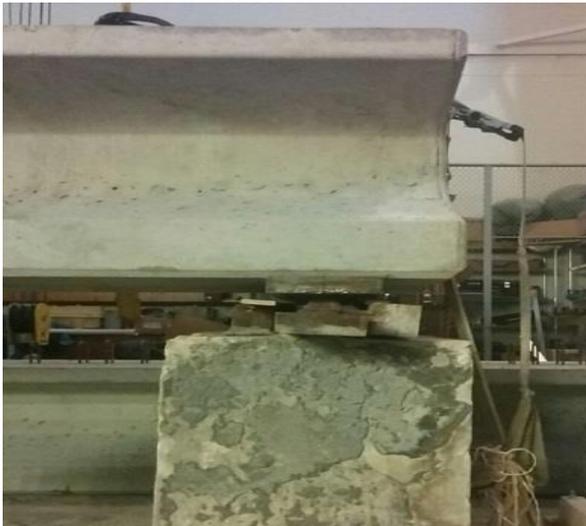
Fig. 10. Central load application, girder CF2.

Two 0.91 m high concrete pedestals were used as support blocks for the girder load testing. A steel W-shape and plates were used to apply the point load uniformly along the width of the girder (Fig. 10). To simulate simple supports, a steel roller and plate assembly was used at each end (Fig. 11). A load cell with 2669 kN capacity was used, and hydraulic pump was used to apply load through the load cell. The machine was handled manually with a loading rate of 22 kN per step and one step per two seconds until the cracking load was observed. Cracks were monitored regularly and marked on the girder surfaces. Once the cracking load was reached, the loading rate was reduced to 9 kN per step until failure. Failure was defined as the step at which the loading could not be increased anymore with additional loading steps, accompanied by rapid deflection and cracking increase. All test data, such as load, strain and deflection were automatically collected through a data acquisition system.

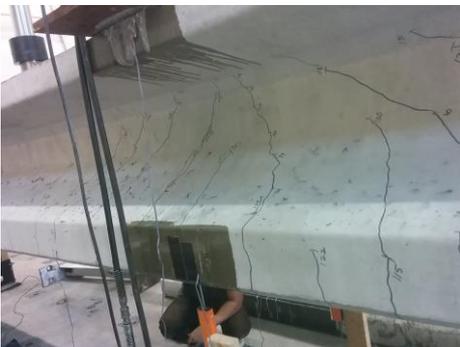
Fig. 12. Cracking in girders.

(a) First crack in GC (at 418 kN load).

(b) Cracking at failure, GC.

(c) Cracking in GF1.

Fig. 12 shows photographs of crack patterns in the girders. As expected, flexural cracks initiated near mid-span and gradually progressed along the depth and outward from the mid-span with increasing loads. Some cracks changed from vertical flexural type to inclined flexure-shear type at some distance from mid-span. As shown in Table VI, the first cracking loads in girders GF1 and GF2 were about 14% and 7% more than in GC, respectively, showing the beneficial effect of flexural FRP in delaying crack development. However, cracks initiated earlier in girder GF2 than in girder GF1. Clearly, the U-wrapping in girder GF1 was the key in delaying crack development, even though GF2 had two layers of FRP. The first cracking loads and the subsequent change in girder stiffnesses are clearly observed in the load-deflection plots in Fig. 13. The maximum vertical deflections (average of the two central LVDTs) at the mid-span were plotted herein. The measured deflections from the two LVDTs were close, showing that the girders were symmetrically loaded in the transverse direction, and no twisting took place during testing.

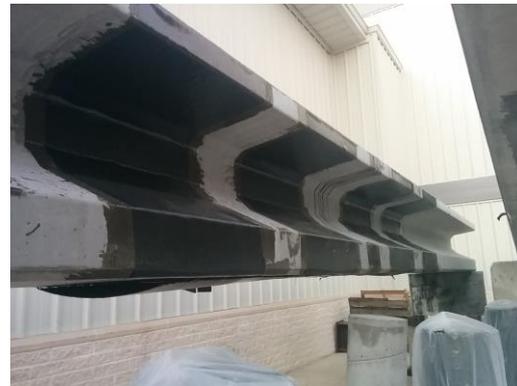
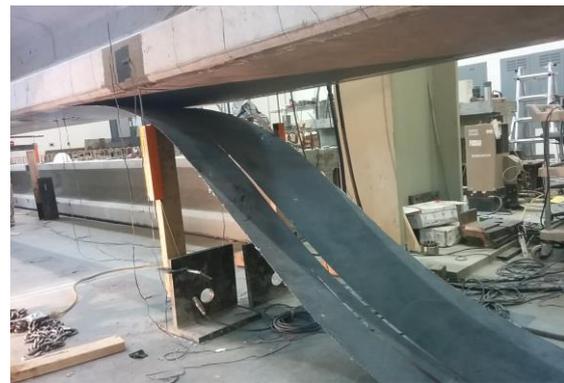
Fig. 14. FRP debonding at failure.

(a) Girder GF1.

(b) Girder GF2.

With increased loading beyond first cracking, the number of cracks and the crack widths increased. As the girders approached failure, deflections increased at a high rate with minimal load increments. The load dropped with increased deflection at the failure load, signifying the girder failure. In girder GC, failure was initiated by prestress yielding, while the FRP layers debonded at the epoxy interface in a sudden manner with a loud noise in GF1 and GF2 (Table VI). FRP-epoxy debonding photographs are presented in Fig. 14, showing that the FRP clearly debonded at the epoxy interface.
