# Study of Microscopic Analysis and Nonlinear Behavior of Damaged Steel Pipe Using Composite Materials

**Abstract** -This paper presents studies of microscopic analysis and nonlinear behavior of composite system for the rehabilitation of steel pipes by analytical models, based on the fracture mechanics and finite element techniques were developed to evaluate the deflection, failure pressure (blister pressure) and stress strain curves for damaged area [1,2].

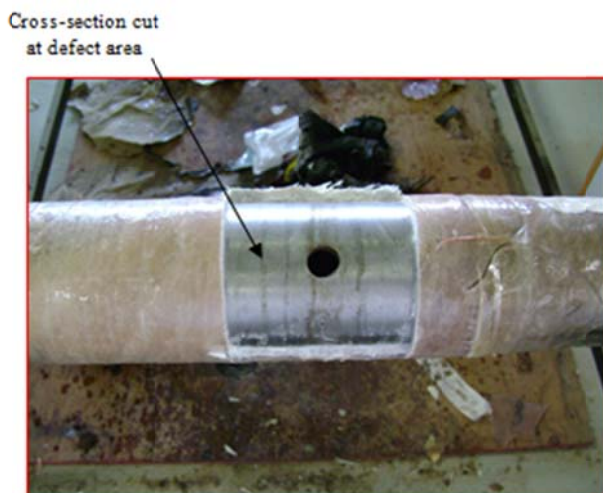
Optical microscopic tests were carried out to examine the microstructure of failure layer of pipes as shown in Fig.2. A number of different sizes samples were carefully cut from failed pipe using small hand hocksaw to minimize damage during sample preparation as shown in Fig.3. Each sample was mounted in a polyester resin in the form of a small mould as shown in Fig.4. All samples were labeled for identification. The molded samples were ground to flatten the surface and remove rough edges using a grinding machine with silicon carbide paper. When the surface of the sample became flat, it was polished using an oil based cloth until all scratches disappear. After that, the samples were examined by optical microscopy to observe any micro-cracks or delamination in the samples.

Fig. 2. Shows a photograph of the sampling area of the pipe.

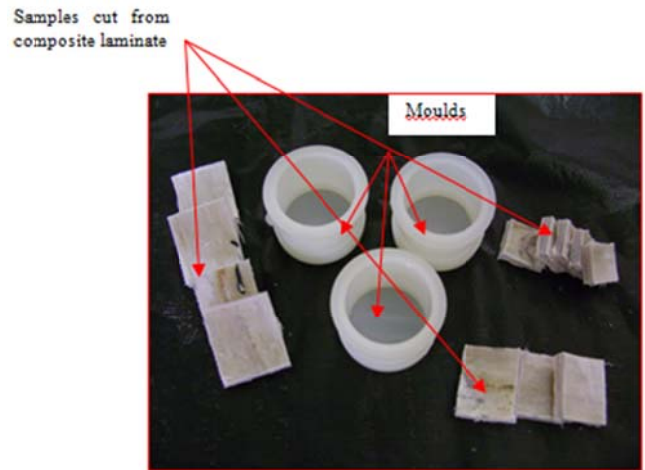
Fig. 3. Samples for microscopic examination.

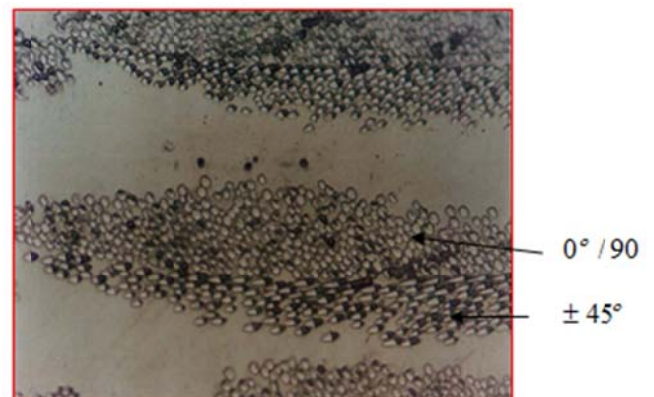
Figure 5 shows an optical micrograph of a polished sample of composite laminate (as manufacturing). The small circles represent the fibers aligned at warped angles  $[0/90^\circ/\pm 45^\circ]_s$ , while matrix or resin is around the fibers.

Fig.5. Shows photo-micrograph of a cross-section of repairing composite laminate.
