# Nondestructive Testing of FRP Composite Structural Components and FRP Rehabilitated Bridge using Digital Tap Testing

Udaya B. Halabe<sup>1</sup>, Ruben M. Joshi<sup>1</sup>, and Hota V. S. GangaRao<sup>1</sup>

<sup>1</sup> Constructed Facilities Center, Department of Civil and Environmental Engineering  
West Virginia University  
Morgantown, WV, USA.

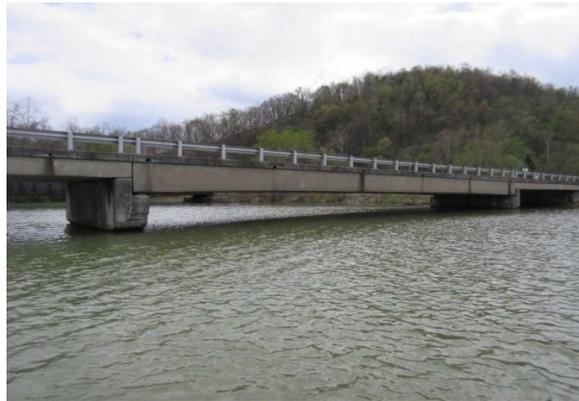
Fig. 3. West Elevation of the Whiteday Creek Bridge [4]

This section talks about the field testing conducted on a concrete box-beamed bridge over the Whiteday Creek, West Virginia (Fig. 3). The box beams of the Whiteday Creek Bridge, which had significant corrosion damage, were repaired by a contractor using Carbon Fiber Reinforced Polymer (CFRP) fabric (Fig. 4). Digital Tap Testing was conducted on the CFRP bonded beams on July 15, 2017 to locate debonds between the CFRP fabric laminate and the underlying concrete surface, so that the contractor could immediately repair them. While conducting the test with Digital Tap Testing, the striking force should be high enough to give numbers on the digital display on the device. Low tapping force results in error message

The debonds identified from the nondestructive testing were marked so that the repair work could be conducted immediately by the contractor. Small sized debonds were repaired by injecting resin into them while large debonds, especially bulges, were repaired by cutting off the CFRP fabric and replacing them with new fabric. After the repair works, a quick assessment of the CFRP bonded beams was needed to ensure that no more debonds were present. Thus, digital tap testing was done again on October 2, 2017 to evaluate all the previously detected and repaired debonds.
