Analyzing and Identifying Various Approaches for Crankshaft Failures

A state-of-the-art Review

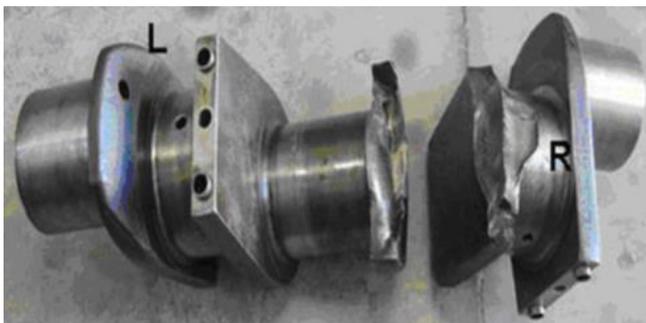
Figure 3: (a) Fracture Surface in the Crankshaft;
(b) Fracture Surface in the Crankshaft
