Nondestructive Testing of GFRP Composite Bridge Decks Using Active Infrared Thermography

Abstract— Aging of reinforced concrete bridge decks is one of the major problems faced by the engineering community today, with concrete cracking and the steel reinforcement corroding due to exposure to deicing chemicals, thus resulting in shorter service life. An alternative to the degrading bridge decks made of concrete and steel is the use of Glass Fiber Reinforced Polymer (GFRP) composite bridge decks, which are noncorrosive. Use of GFRP bridge decks can lead to enhanced durability. However, ensuring continued structural integrity of GFRP bridge decks requires a reliable method of evaluation for periodic testing in the field environment. Nondestructive Testing (NDT) using Active Infrared Thermography (IRT) can help to detect subsurface defects in GFRP bridge decks that may occur because of vehicular loading and the harsh environmental conditions. Infrared Thermography (IRT) is an extensively used NDT technique for inspection of civil infrastructure, because of its portability and easy-to-handle features. This paper discusses the use of advanced and conventional IRT techniques for detecting

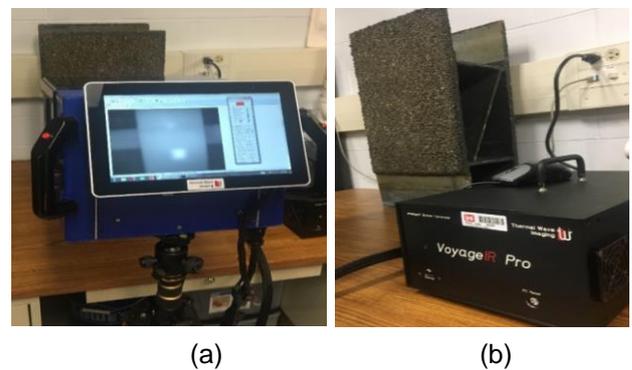
Fig. 1. (a) Inspection Head, and (b) I/O System Controller for Advanced Infrared Imaging Equipment (VoyageIR Pro)

The advanced infrared imaging equipment (VoyageIR Pro) consisted of a system of hardware and software components (Figure 1). The hardware included the inspection head with infrared camera, computer-controlled heating source, and a tablet computer with touchscreen monitor, all of which were mounted on a tripod stand (Figure 1a) and connected by cables to an Input/Output (I/O) Controller box (Figure 1b). The miniature long-wave uncooled microbolometer infrared camera included a 14.25mm lens with a 640x480 pixels Focal Plane Array (FPA) and image capture frequency of 30Hz (30 frames per second). It detected radiation in the spectral range of 8 to 14 microns. The heat source consisted of an array of fully synchronized miniature heat lamps with precise control over key parameters like pulse width and amplitude. The heat flux from the heat source was 800 W/m^2 at a distance of 24" (0.61m). The integrated 10" (0.25m) touchscreen tablet computer's display featured a streamlined software user interface that provided complete control and remote system operation. However, the backbone of this system was the Input/Output (I/O) System Controller (Figure 1b), which allowed a network of electronics to perform all the major functions, such as heat source synchronization and control, digital data capture and analysis, and trigger I/O. The associated software housed in the tablet computer was an integral part of the system, which was designed to provide a user-friendly interface and easy access to all the program functions. The software allowed capturing and processing of the data with options to set up all the necessary parameters like trigger mode, capture rate and heating time. The thermographic signal reconstruction could be done using the software program which allowed TSR processing and reconstruction of the captured data. The reconstructed

The specimens were placed on the table and the advanced infrared imaging equipment (VoyageIR Pro) was set up on a tripod stand such that the surface of the specimen was at a distance of 24" (0.61m) from the in-built infrared camera of the system, as shown in Figure 1a. The infrared camera on the device was maintained at a height of 42" (1.07m) from the ground to achieve a proper testing setup. The system also had a 9" (0.23m) long shield in the front to prevent any thermal noise from the surrounding while the thermal data from the specimen was being captured. The surface of the specimen was heated for different time durations (50s, 100s, 200s) in different experiments to determine the optimal heating duration (for the GFRP bridge deck specimens) for the VoyageIR Pro, which is an advanced infrared imaging equipment (Figure 1). This system was used to capture the sequence of thermal images (30 frames per second) during the heating process and for 30 seconds after the heating stopped. After the device captured the thermal data and the surface was still in thermally excited state, the low-cost conventional infrared camera (Figure 2) was used to capture still (single shot) thermal image of the surface of the bridge deck specimen.

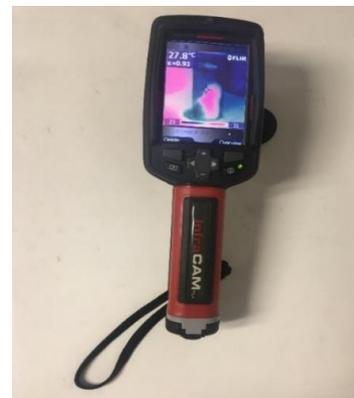
Fig. 2. Low-cost Infrared Camera

The conventional infrared equipment used for this study was a low-cost handheld infrared camera (Figure 2), which could capture thermal images of a surface with temperatures in the range of -10°C to $+350^\circ\text{C}$ with an accuracy of $\pm 0.1^\circ\text{C}$ at a temperature of 30°C . The 3.5" (0.09m) LCD display on the infrared camera provided a color thermal image with a resolution of 120×120 pixels. This device, weighing 1.21 pounds (0.55 kg), stored thermal images in the format of standard radiometric JPEG files on a removable SD card. These JPEG files could directly be studied to identify debonds. The thermal image files could further be analyzed using the associated software that provided information on minimum, maximum, and average temperatures of a selected area in the image.

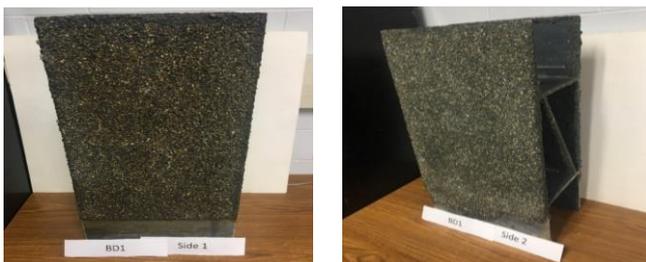
Fig. 3. Side 1 (left) and Side 2 (right) of the GFRP Bridge Deck Specimen BD1

The specimen BD1 was made of E-glass fibers and polyester resin (Figure 3). Its overall plan size was 24" x 12" (0.61m x 0.305m) with an overall depth of 8" (0.2m). The thickness of the flanges was 0.5" (12.7 mm) while that of the web was 0.35" (8.9mm) and of the diagonal members was 0.25" (6.35mm). This composite deck weighed about 15 lb/ft² (73 kg/m²). Air-filled debonds were placed in between the wearing surface and the underlying FRP deck surface. The wearing surface was 3/8" (9.5mm) thick and made of specially selected blend of aggregates, i.e., Glacial Gravel – Basalt, Quartzite and Granite, mixed with two-part liquid polymer system. There were two air-filled debonds of sizes 2" x 2" (51mm x 51mm) and 3" x 3" (76mm x 76mm) on Side 1 of the specimen and two air-filled debonds of sizes 1" x 1" (25mm x 25 mm) and 1/2" x 1/2" (12.7mm x 12.7mm) on Side 2. All the debonds on specimen BD1 were 1/16" (1.6mm) thick.

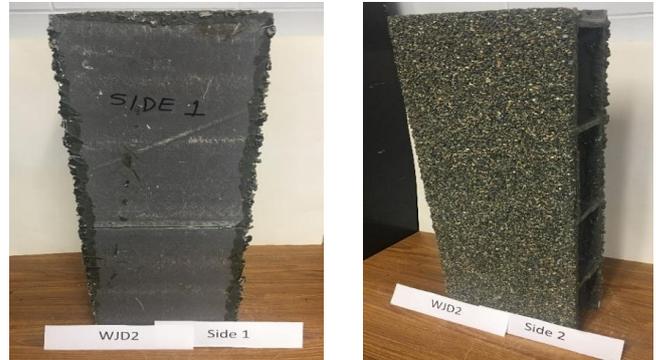
Fig. 4. Side 1 (left) and Side 2 (right) of the GFRP Bridge Deck Specimen WJD2

The specimen WJD2 was a low-profile GFRP bridge deck specimen made of E-glass fiber and vinylester resin (Figure 4). The plan size of WJD2 was 24" x 8" (0.61m x 0.20m) with an overall depth of 4" (0.1m). The thickness of the flange was 0.45" (11.4mm) with a thickness of 0.6" (15.2mm) at the flange-to-flange junction. This composite deck weighed about 10 lb/ft² (49 kg/m²). A 3/8" (9.5mm) thick wearing surface, consisting of a two-component polysulphide-epoxy-based overlay system, was applied on Side 2 of the specimen. Both sides of the specimen WJD2 had a water-filled delamination of size 3" x 3" (76mm x 76mm) placed centrally in the flange junction. They were located at 0.32" (8.1mm) from the top of the GFRP deck surface on both sides but Side 2 had an additional 3/8" (9.5mm) thick wearing surface. Side 1 did not have any wearing surface.

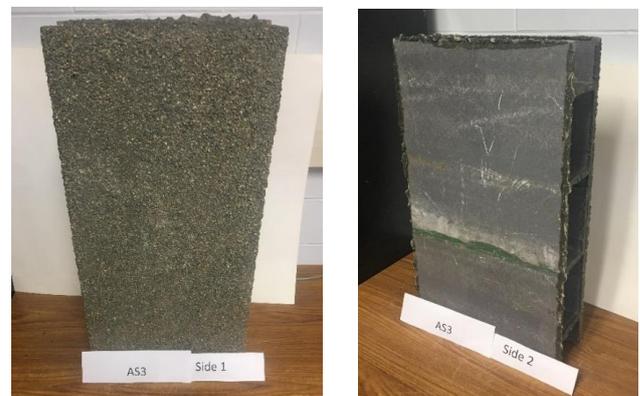
Fig. 5. Side 1 (left) and Side 2 (right) of the GFRP Bridge Deck Specimen AS3

The specimen AS3 was also a low-profile 4" (0.1m) thick GFRP bridge deck made of E-glass fiber and vinyl-ester resin, with a plan size of 24" x 12" (0.61m x 0.305m) as shown in Figure 5. Side 1 of specimen AS3 had 3/8" (9.5mm) thick wearing surface which consisted of two-component polysulphide-epoxy-based

overlay system. On Side 1, a 3" x 3" (76mm x76mm) sized air-filled debond of thickness 1/16" (1.6mm) was placed in between the wearing surface and the underlying deck. Side 2 did not have any wearing surface. There was a 3" x 3" (76mm x76mm) thick air-filled delamination with 1/16" (1.6mm) thickness on Side 2 in the flange-to-flange junction.

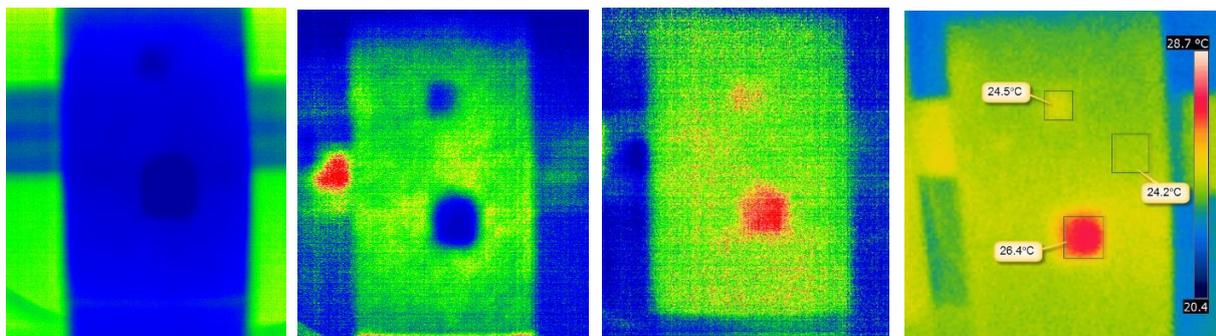
Fig. 6. From left: TSR image, 1st derivative image, 2nd derivative image, and conventional infrared image of Side 1 of the GFRP bridge deck specimen BD1 after 50 seconds of heating

The infrared thermography testing of bridge deck specimens using advanced infrared imaging system (Figure 1) gave results in the form of TSR images, and 1st and 2nd derivative images. In addition, still images using the conventional infrared camera (Figure 2) were also captured. For 50 seconds of heating, the defects in Side 1 of bridge deck specimen BD1 (air-filled debonds between the wearing surface and the underlying GFRP deck) could be seen in all the images: TSR image, 1st derivative image, 2nd derivative image, and the conventional still image (Figure 6). The defects in the 1st derivative image were sharper than in the other images. For the smaller air-filled debonds in Side 2 of specimen BD1 (Figure 7), only the 1st derivative image showed the defects prominently. The conventional thermal image did not show the defects clearly after 50 seconds of heating. Figures 8 and 9 show the results obtained with 100 seconds of heating for bridge deck specimen BD1. The conventional thermal image indicated that the surface temperature corresponding to the largest defect was 4.5°C higher than the surrounding temperature (Figure 8). Figures 8 and 9 also indicate that the 1st derivative image is the clearest and the most reliable processed image.

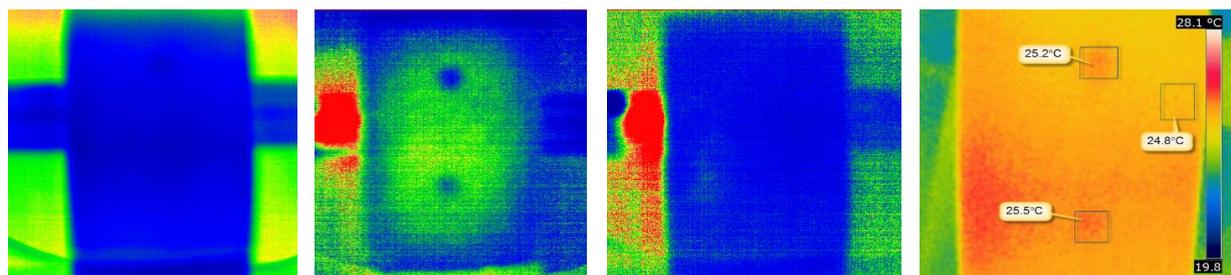
Fig. 7. From left: TSR image, 1st derivative image, 2nd derivative image, and conventional infrared image of Side 2 of the GFRP bridge deck specimen BD1 after 50 seconds of heating

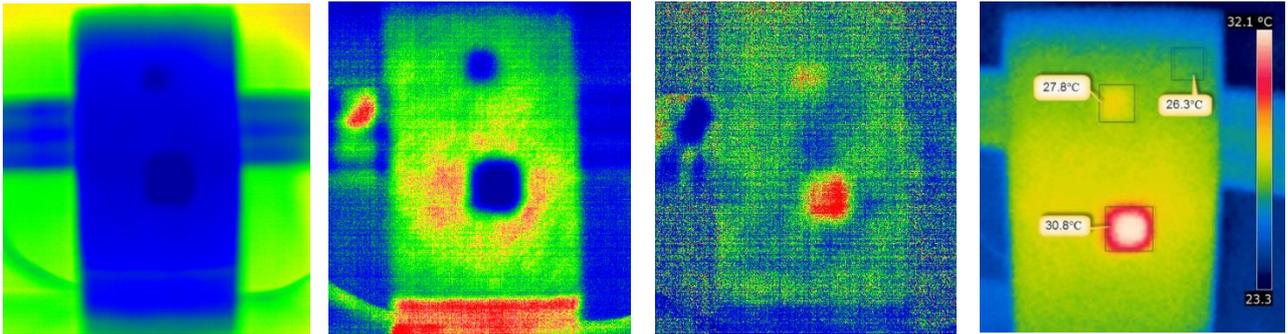
Fig. 8. From left: TSR image, 1st derivative image, 2nd derivative image, and conventional infrared image of Side 1 of the GFRP bridge deck specimen BD1 after 100 seconds of heating

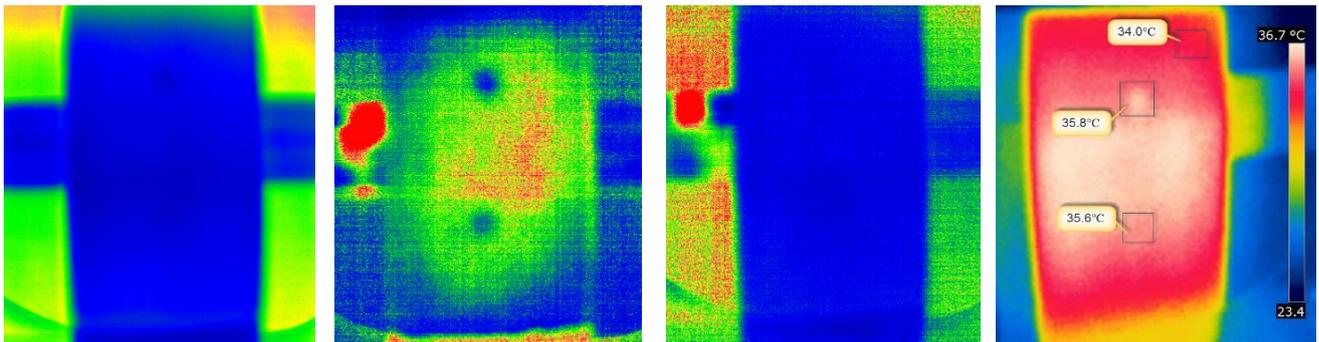
Fig. 9. From left: TSR image, 1st derivative image, 2nd derivative image, and conventional infrared image of Side 2 of the GFRP bridge deck specimen BD1 after 100 seconds of heating

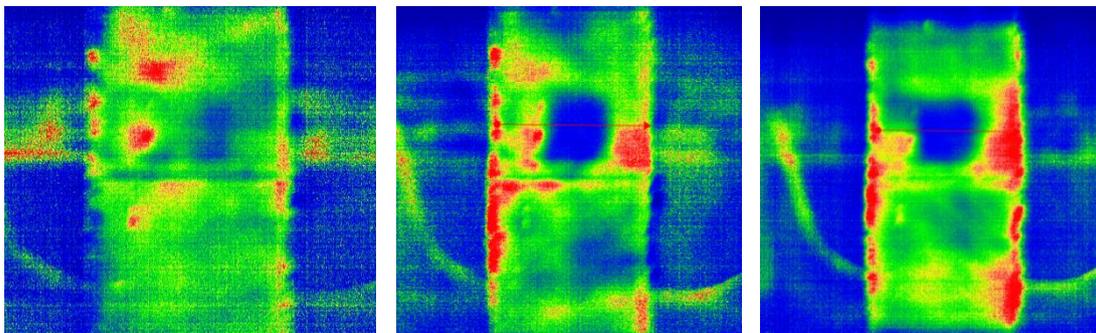
Fig. 10. 1st derivative images of uncovered Side 1 (without wearing surface) of the GFRP bridge deck specimen WJD2 after 50 seconds (left), 100 seconds (center), and 200 seconds (right) of heating

For bridge deck specimen WJD2 (with water-filled delamination within the deck flanges), Side 1, with no wearing surface, showed delamination after 50s, 100s, and 200s of heating (Figure 10). However, Side 2 (covered with wearing surface) did not clearly indicate the water-filled defect after 50s of heating (left figure in Figure 11). Only after 100s and 200s of heating, the delamination could be detected, but the boundary of the delamination could not be noted clearly (Figure 11). Figure 12 shows the conventional thermal images of uncovered Side 1 (without wearing surface) of specimen WJD2 after 50s, 100s, and 200s of heating. The 3" x 3" (76mm x 76mm) sized delamination could only be detected after 100s of heating, with the temperature above the delamination being 3.4°C higher than the surrounding areas. The covered Side 2

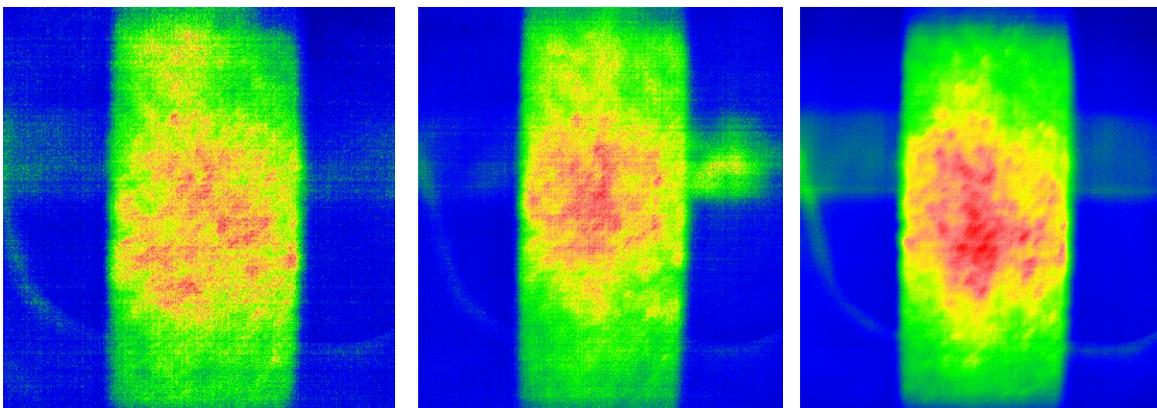
Fig. 11. 1st derivative images of covered Side 2 (with wearing surface) of the GFRP bridge deck specimen WJD2 after 50 seconds (left), 100 seconds (center), and 200 seconds (right) of heating

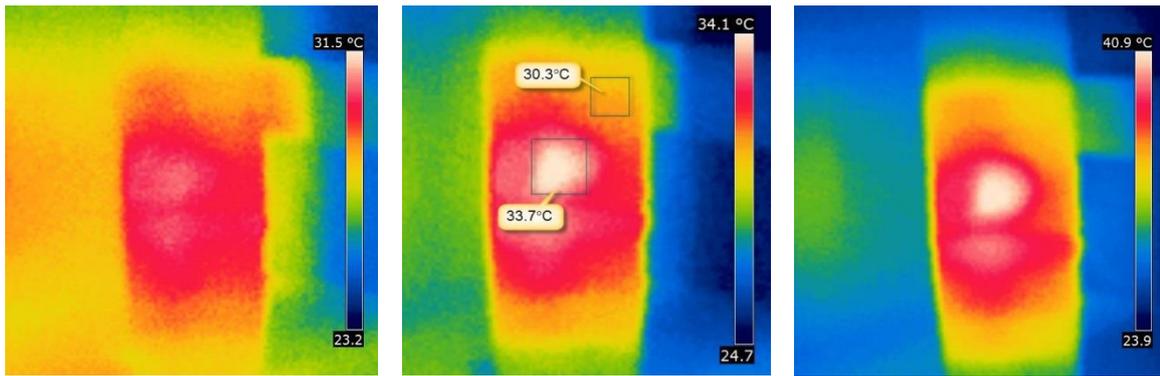
Fig. 12. Conventional thermal images of uncovered Side 1 (without wearing surface) of the GFRP bridge deck specimen WJD2 after 50 seconds (left), 100 seconds (center), and 200 seconds (right) of heating

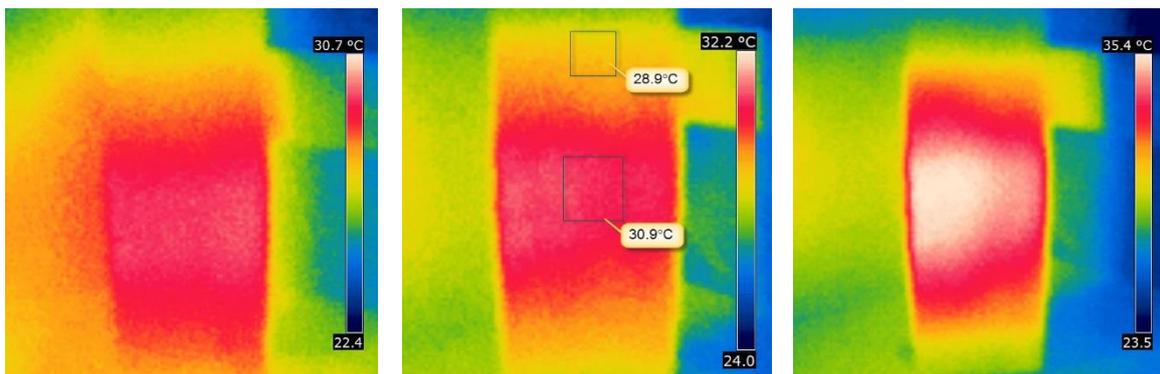
Fig. 13. Conventional thermal images of covered Side 2 (with wearing surface) of the GFRP bridge deck specimen WJD2 after 50 seconds (left), 100 seconds (center), and 200 seconds (right) of heating

(with wearing surface) did not show clear indication of the subsurface delamination in conventional thermal images for 50s and 100s heating durations (Figure 13). The infrared image corresponding to 200s heating duration (last image in Figure 13) shows the presence of delamination, but the boundary of the delamination cannot be deciphered. In summary, the 1st derivative images from advanced infrared imaging system could detect subsurface defects better than conventional images from the low-cost infrared camera. Also, the deeper subsurface defects (with wearing surface) required longer duration of heating as compared to the shallow defects (without wearing surface).

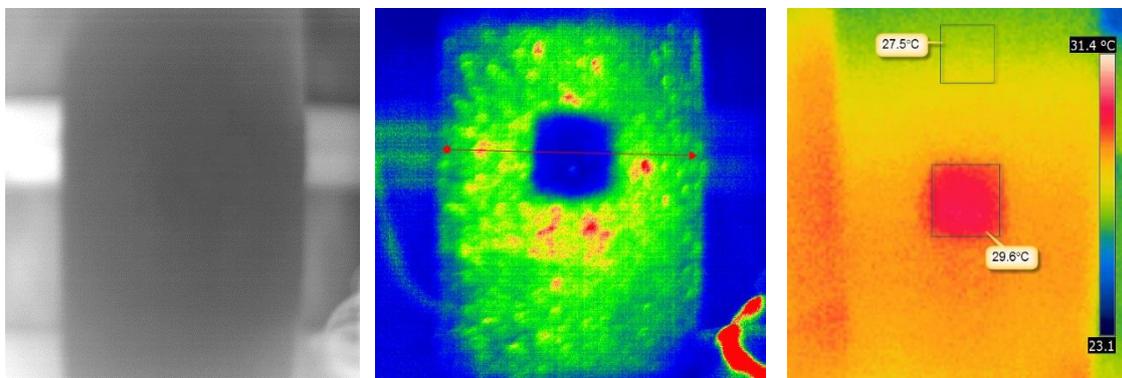
Fig. 14. Raw image (left), 1st derivative image, and conventional thermal images of Side 1 of GFRP bridge deck specimen AS3 after 50 seconds of heating

Infrared thermography testing of bridge deck specimen AS3 gave results as shown in Figures 14 and 15. The raw images for both sides of AS3 after 50s of heating was not indicative of the defects. The debond on Side 1 and the delamination on Side 2 were clearly visible in the 1st derivative images after 50s of heating. The conventional thermal images of Side 1 and Side 2 also showed the presence of defects (with temperature difference of around 2°C), but the defect boundary was not prominent for Side 2. The processed images (1st derivative image) obtained through TSR technique was very helpful to locate the subsurface defects while the raw images did not show the presence of the defects (Figures 14 and 15).

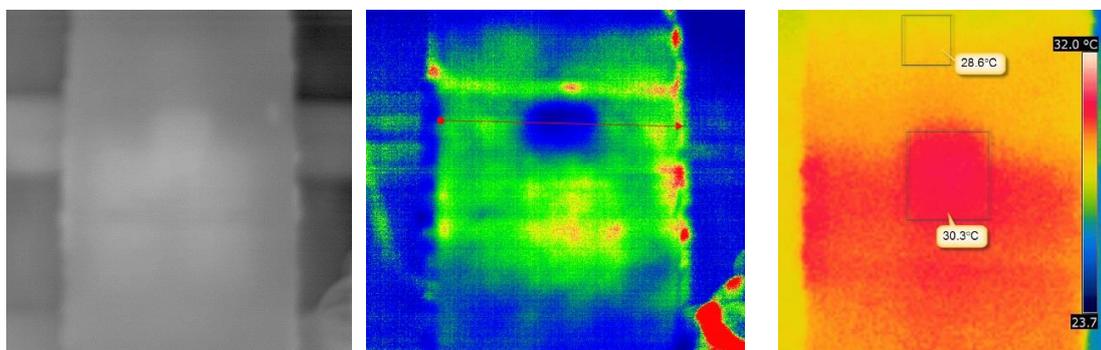
Fig. 15. Raw image (left), 1st derivative image, and conventional thermal images of Side 2 of GFRP bridge deck specimen AS3 after 50 seconds of heating
